## Installation Instructions for 42488, 42489, 44494, 44495

## 1984-96 Leather Console Lid Cover

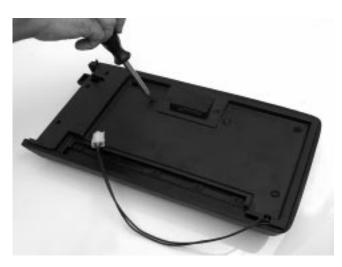
**Step 1:** Remove center console door by removing the screws that secure the console lid to the hinge and unplugging the console light assembly.

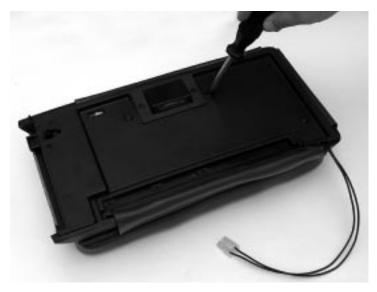
**Step 2:** Lay console lid face down and remove the screws on the plastic backing plate. (84-89 DO NOT REMOVE the 2 screws that hold the light.) Remove backing plate. (Note direction of console lid spring and button for re-installation.)
