## Installation Instructions for 42488, 42489, 44494, 44495

## 1984-96 Leather Console Lid Cover

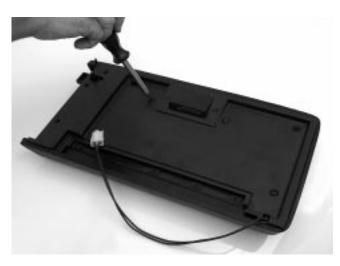
**Step 1:** Remove center console door by removing the screws that secure the console lid to the hinge and unplugging the console light assembly.

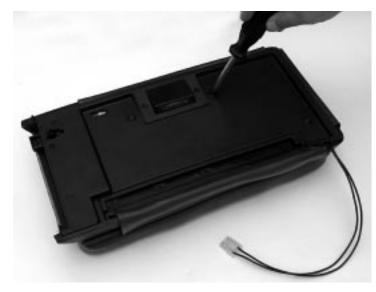
**Step 2:** Lay console lid face down and remove the screws on the plastic backing plate. (84-89 DO NOT REMOVE the 2 screws that hold the light.) Remove backing plate. (Note direction of console lid spring and button for re-installation.)

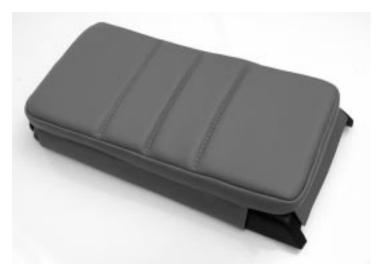
**Step 3:** Cut the double-sided tape in lengths to fit locations shown in picture. Be sure to clean area thoroughly before applying. You can substitute the double-sided tape with upholstery glue or similar for a firmer hold.
